Investigation of the Bond Strength Between Existing Concrete Substrate and UHPC as a Repair Material

Article · February 2017

Ahmed F. AlHallaq, Bassam A. Tayeh, Samir Shihada

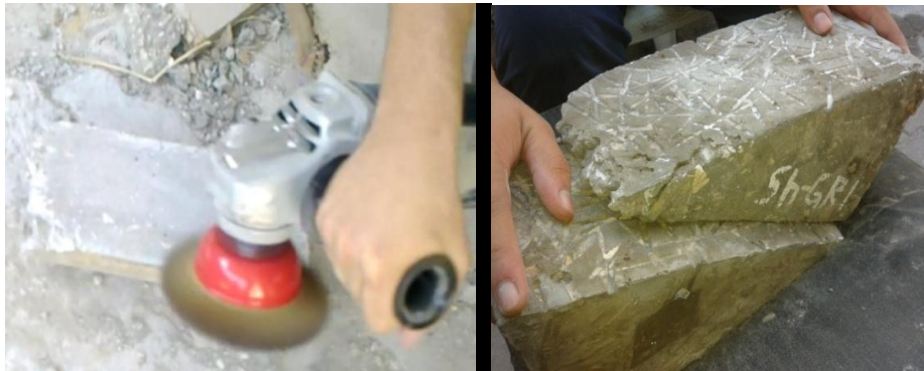
Figure 3: Wire brush and Random Scarifying Treatment Techniques.

- As-cast: is obtained by casting substrata surface against steel formwork,
- mechanical wire brush for 10 min/m²,
- scarifying was conducted by an electrical grinder to obtain a grid of parallel groves lines in two dimensions and random groves,
- scabbling by using a mechanical drill to obtain a surface partially chipped.
- Figure 3 shows the surfaces which were prepared using a wire brush and random scarifying.

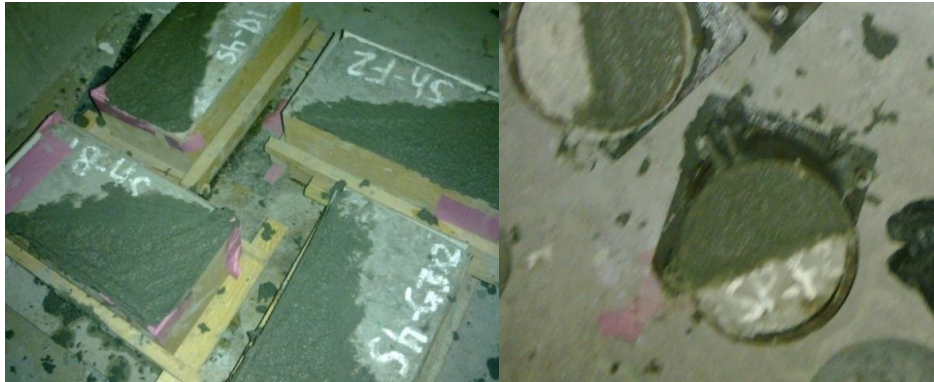
Figure 4: Slant shear and splitting test specimens.

The molds are prepared to contain substrata specimens and the cast repair materials casting. The remainder of the mold is filled with the repair material with good compaction, as shown in Figure 4.

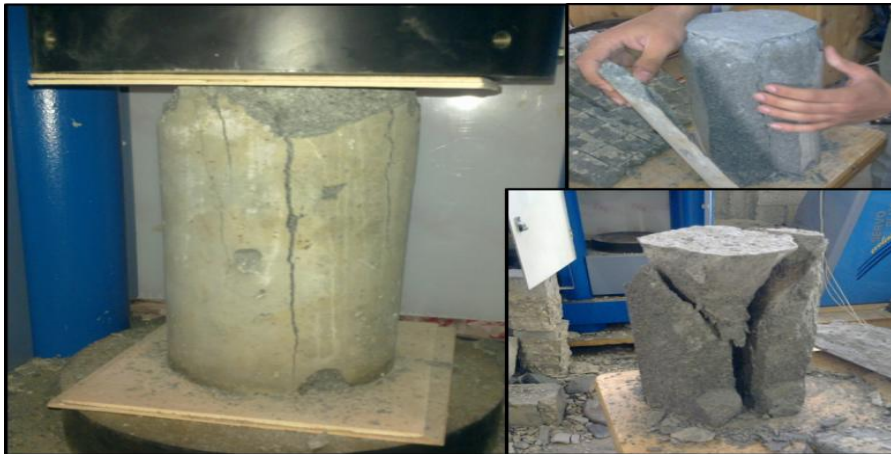
Figure 5: Mode of failure of UHPC cylinder.

The compression strength test was conducted, on the same day, of the bond strength test for substrata and repair material specimens. The standard cylinder specimens which are 30 cm in length and 15 cm in diameter are used to determine the compressive strength of the substrata and the repair material, Figure 5.

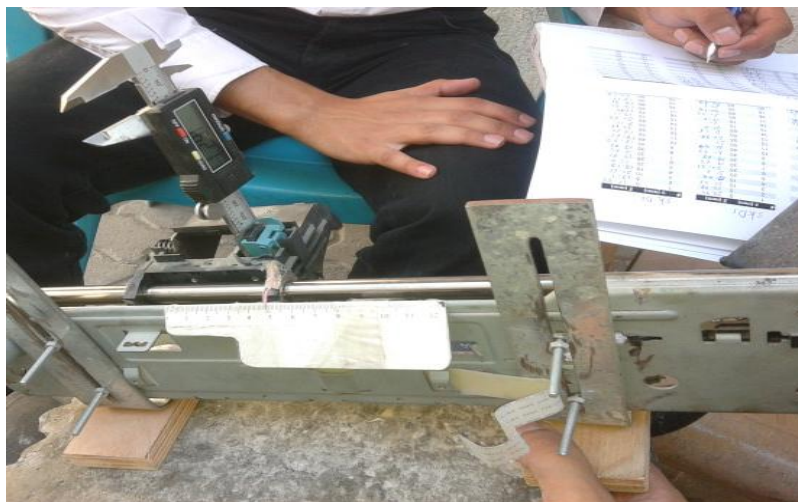
Figure 6: Surface Profile Mapping.

In order to study the effect of surface roughness on the bond between the repair material and the concrete substrate, the roughness of the surface needs to be measured. To evaluate the surface roughness, the specimens surfaces were mapped by the handmade profile meter. A two dimensional profile 10cm long was prepared 3 times in different locations on the surface for each specimen, shown in

Figure 6. In this research, the surface roughness will be described using R_a coefficient, since this coefficient was used in most reviewed literature. This will allow comparing the results of this study with previous literatures. The average roughness, R_a , shown in Figure 7, is given by:

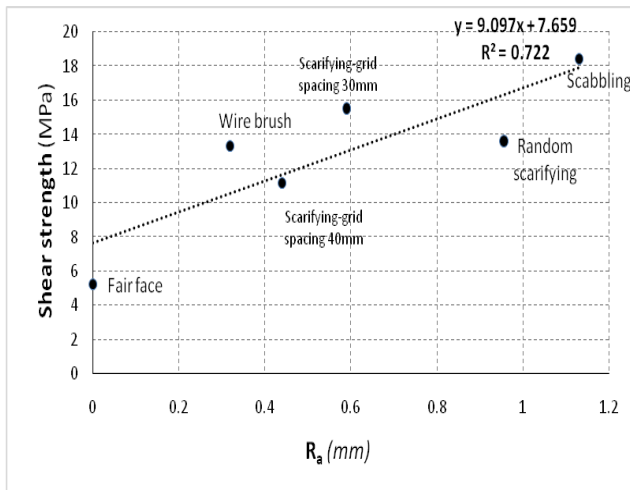
Figure 11: R_a coefficient value vs shear strength.

Table 5 shows the average value of roughness coefficients; R_a , R_z , and R_{max} for each surface treatment techniques. Figure 11 shows the relation between the roughness coefficient R_a and shear strength which is directly proportional. As shown in previous studies [23-25], bond strength depends on the method used to promote roughness of the substrate surface. Previous studies have shown that the jack-hammer preparation technique is potentially harmful for the concrete substrate superficial layer. Probably, this explains why wire brush gives shear strength values more than the general trend in Figure 11. As a result, increasing the groove depth and width, without damaging the substrate superficial layer can increase the shear strength and this is similar to a finger print phenomenon.

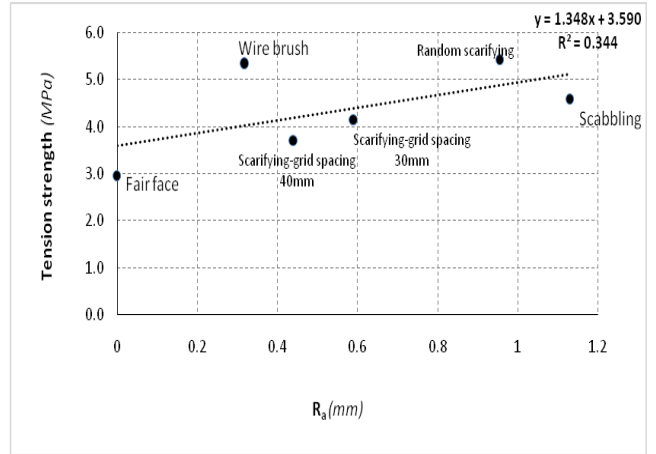
Figure 12: R_a coefficient value vs tension strength

Figure 12 shows the relation between the roughness coefficient R_a and tension strength. The linear regression indicates that the effect of surface roughness is insignificant according to the slope of regression line in comparison with Figure 11. Coefficient of determination, R_a equal to 0.34. Statically, it means the linear regression is not representative for this data. In other words, surface roughness, presented in R_a coefficient, is not compatible with tension strength. This indicates that tension strength is more related to the cementation of the repair material. This result is in a good agreement with the results obtained by [26, 27].

From the above analysis, one can conclude that increasing surface roughness enhances bond strength in shear significantly and proportionally up to 250%. But for tension strength, the effect of roughness will be less significant and just improves the tension strength by about 80%. This is clearly presented by the slop of linear regression of Figure 11 and Figure 12 and coefficient of determination, R_a , where the slopes are 9.1 and 1.3 for shear and tension strength respectively and coefficients of determination are 0.7 and 0.3 for shear and tension strength, respectively.
