The 2<sup>nd</sup> International Conference on Rehabilitation and Maintenance in Civil Engineering

## Utilization of Ultra-High Performance Fibre Concrete (UHPFC) for Rehabilitation – a Review

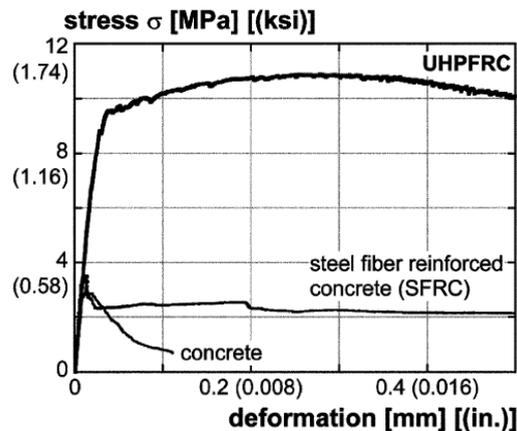
UHPFC belongs to the group of high performance fiber reinforced cementitious composites (HPRCC), but offers additional advantage of a very dense low-permeable matrix. Figure 1 shows the example on the uniaxial tensile test results for an UHPFC specimen, conventional steel fiber-reinforced concrete (SFRC), and conventional concrete. The UHPFC exhibits a significantly increased tensile strength and strain-hardening behaviour as compared to other cementitious materials (Habel 2004).

Figure 1. Uniaxial tensile behavior: comparing UHPFC, conventional SFRC and conventional concrete (Habel 2004).

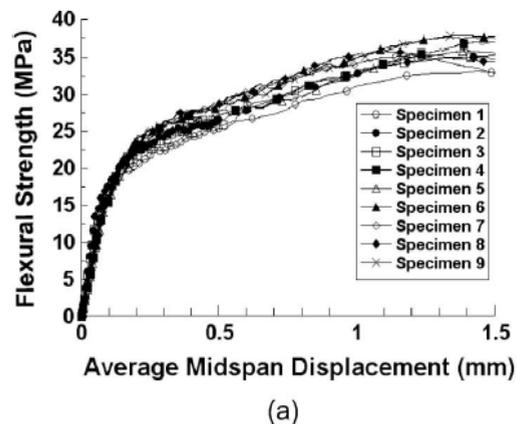
UHPFC has a remarkable flexural strength and very high ductility. According to Richard and Cheyreyz (Richard 1995) the ductility of UHPFC is 250 times greater than that of conventional concrete. The behaviour of UHPFC under flexure loading can be characterized by three phases that is (i) the linear elastic behaviour up to the first cracking strength of the material, (ii) a displacement-hardening phase up to the maximum load, and (iii) a deflection-softening phase after the maximum load is reached. Figure 2 shows a typical load-deflection diagram for UHPFC in bending with the typical phases labelled.

Figure 2. Flexural strength versus midspan displacement (Voo 2004), (a) for  $w$  up to 1.5mm and (b) full experimental curves.

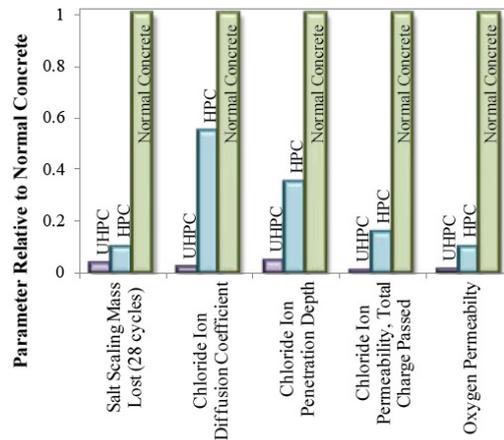
The greatly improved microstructure of UHPFC not only results in higher mechanical strength but also leads to greater durability properties. This makes UHPFC both a high strength and a high performance material. The very low porosity of UHPFC, particularly capillary porosity, leads to great improvements in the durability properties of UHPFC (Voort 2008). From some previous researches, (Voort 2008) show in Figure 3 the various durability properties for UHPC are compared to HPC and normal concrete. The great durability of UHPC may lead to reduce maintenance costs for the material and a possible reduction in the cover concrete required to resist weathering effects compared to normal concrete.

Figure 3. Durability properties of UHPC and HPC with respect to normal concrete (lowest values identify the most favorable material) (Voort 2008).

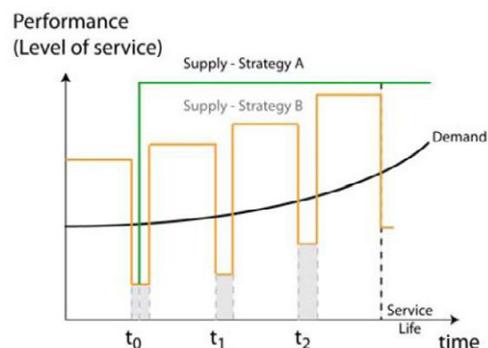
Figure 4 presents the two different strategies of conservation from the end user's or owner's point of view. The traffic demand is continuously increasing in all cases. Strategy B usually induced during the planned service life of the structures, multiple periods of traffic disruptions, shown as shaded areas. Depending on the size of the structure and the extent of the interventions to be realized, these periods of traffic disruption can extend up to several years with dramatic consequences in terms of traffic disturbance, and end users and environmental costs. On the contrary, Strategy A aims at both: decreasing the time spent for the rehabilitation works, and increasing the durability to an extent that will make the rehabilitated structures fulfil all requirements of functionality, serviceability and resistance, for the planned service life, with only minor preventative maintenance. Strategy A is thus highly desirable (Denariè 2006).

Figure 4. Evolution with time of the demand and supply for two conservation strategies.
